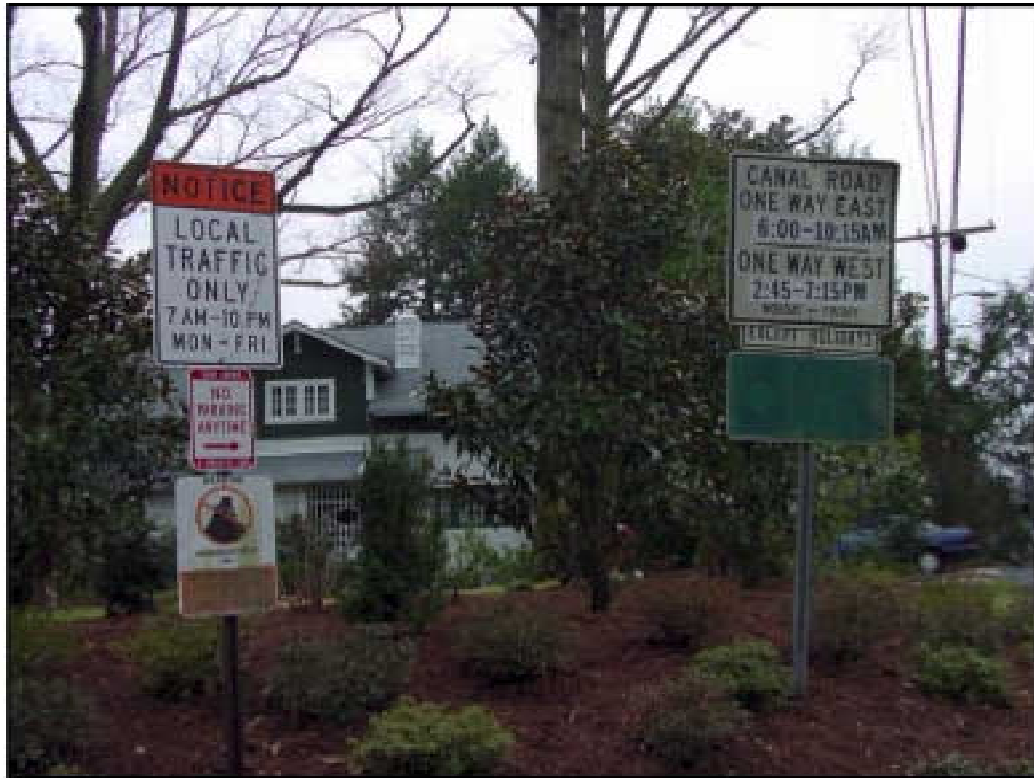
Figure 31
Signs on Clark Place

1. Traffic Operations and pavement markings at Arizona Avenue. During the PM peak hour, through traffic traveling in the left lane drives in what appears to be an oncoming lane.
2. Poor condition of street signs.

1. Modify pavement markings and install additional lane control signals to clarify operations. Figure 32 is an aerial photograph of the intersection showing proposed lane control signals and their operation at various times of the day.
2. Replace street sign.

- Install new signs and lane control signals, and remove pavement markings as shown in Figure 32.

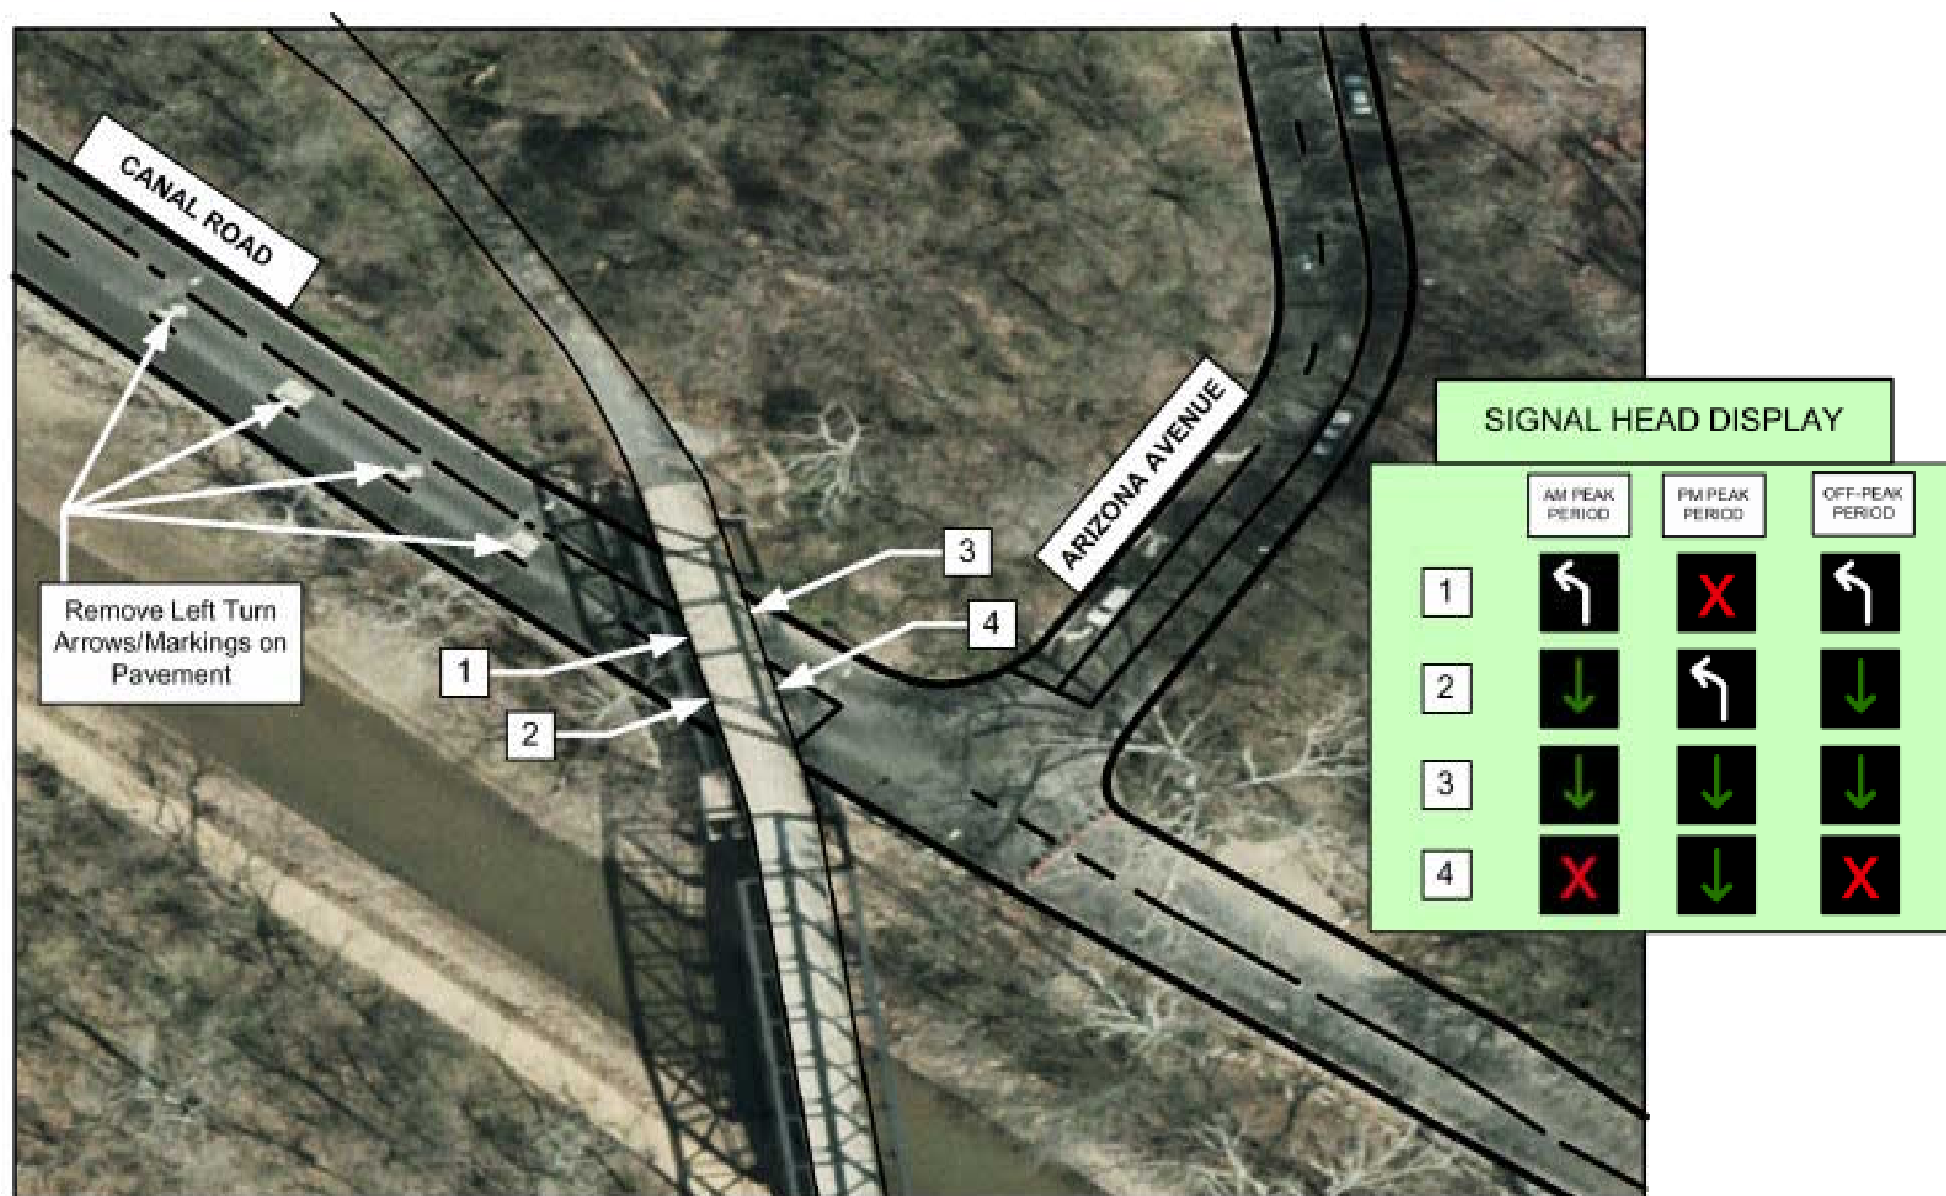
1. As shown in Figure 32, the Arrow/"ONLY" markings on inbound Canal Road could be removed to eliminate any confusion to outbound motorists driving against the markings during the PM peak hour. Lane control signals could be hung from the trail bridge at Arizona Avenue, instructing motorists on which lanes are available to them.

NOTE: Signal Heads to be installed supported from the pedestrian bridge
